FINAL REPORT

Designing, Assessing, and Demonstrating Sustainable
Bioaugmentation for Treatment of DNAPL
Sources in Fractured Bedrock

ESTCP Project ER-201210

MARCH 2017

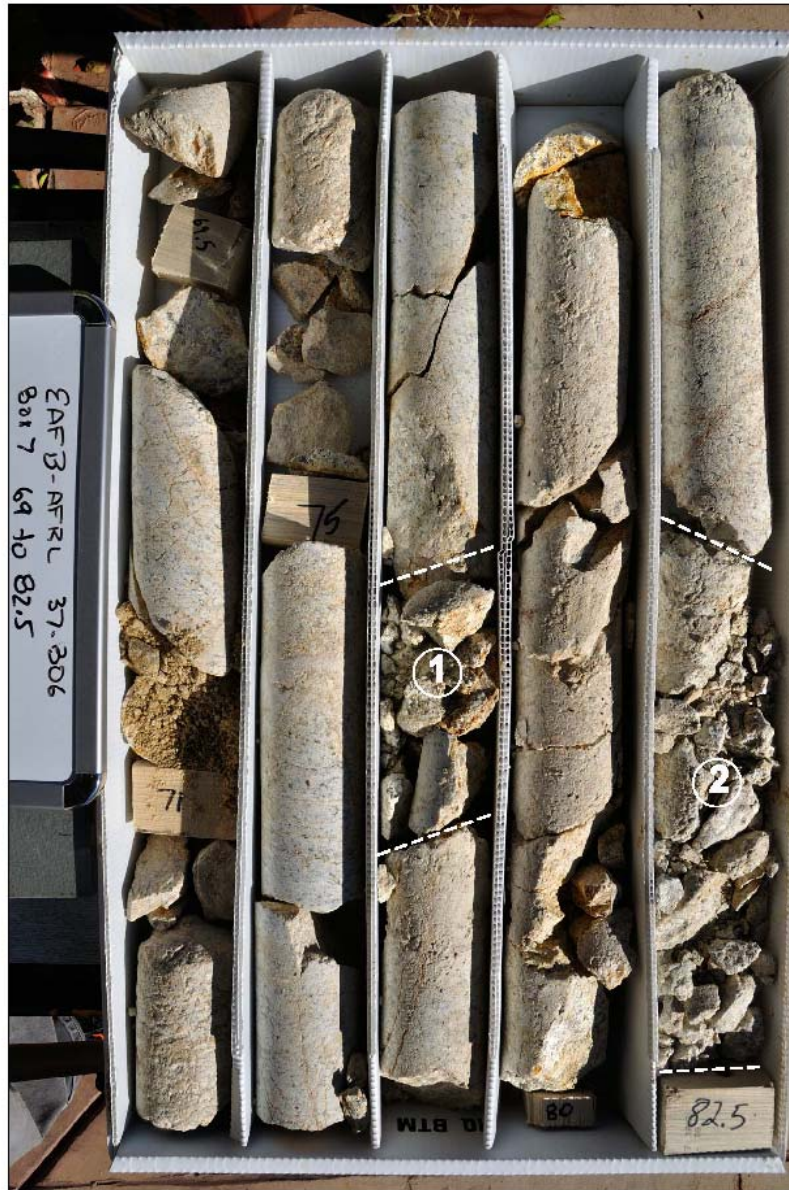
IMAGE	X-REF	OFFICE	DRAWN BY	CHECKED BY	APPROVED BY	DRAWING NUMBER
		CONCORD	SLZ	6/8/13	TA	6/8/13
						148185-B3

The geologic log for boring 37-B06 is presented in Appendix B. Geologic logging included determination of mineralogical content, percent recovery, rock quality designation. The core recovery was generally excellent, with 80% to 100% recovery common for most intervals. Three of the borings, 37-B06, 367-B07 and 36-B09, contained similar lithological sequences, with the rock consisting of the commonly present quartz monzonite with intruded zones of granite. Occasional thin layers of dark mafic material were also observed in the wells. Distinct fracture sets were observed in the core with at least four sets present. The dip of the fractures ranged from nearly vertical (within 10 degrees of vertical) to nearly horizontal.

NOTES:
 1. FRACTURE ZONE 78 TO 79 FT-BGS.
 2. FRACTURE ZONE 81.5 TO 82.5 FT-BGS

Notes: 1. Fracture zone: 78 to 79 ft bgs
 2. Fracture zone: 81.5 to 82.5 ft bgs

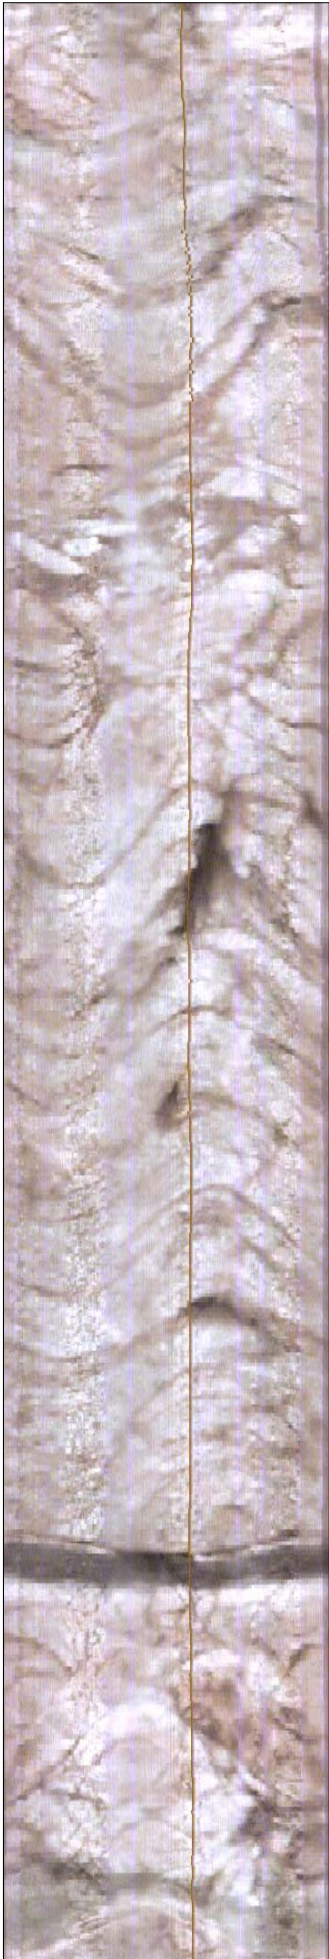
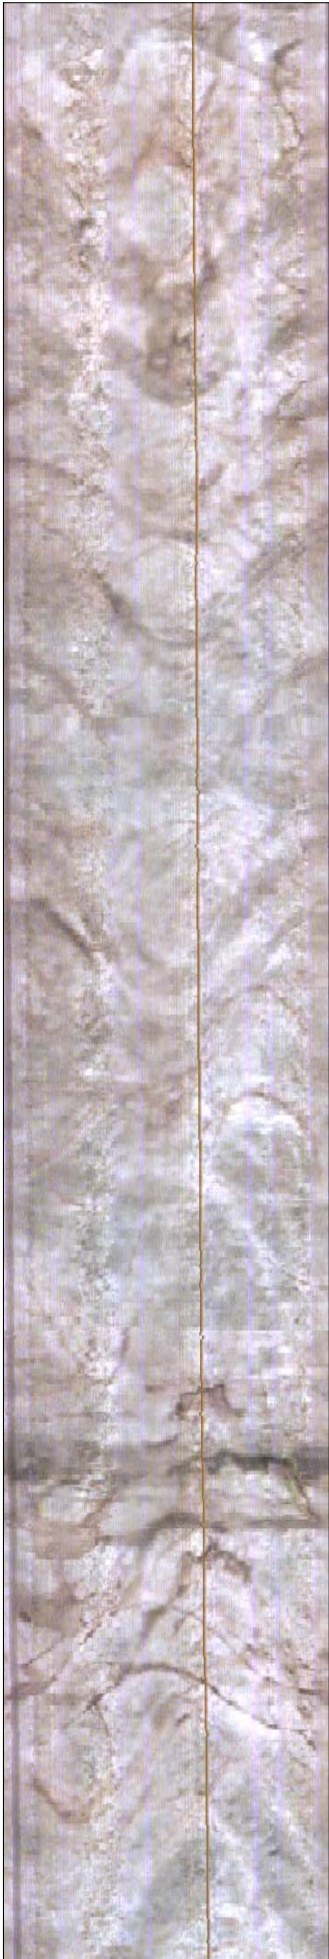
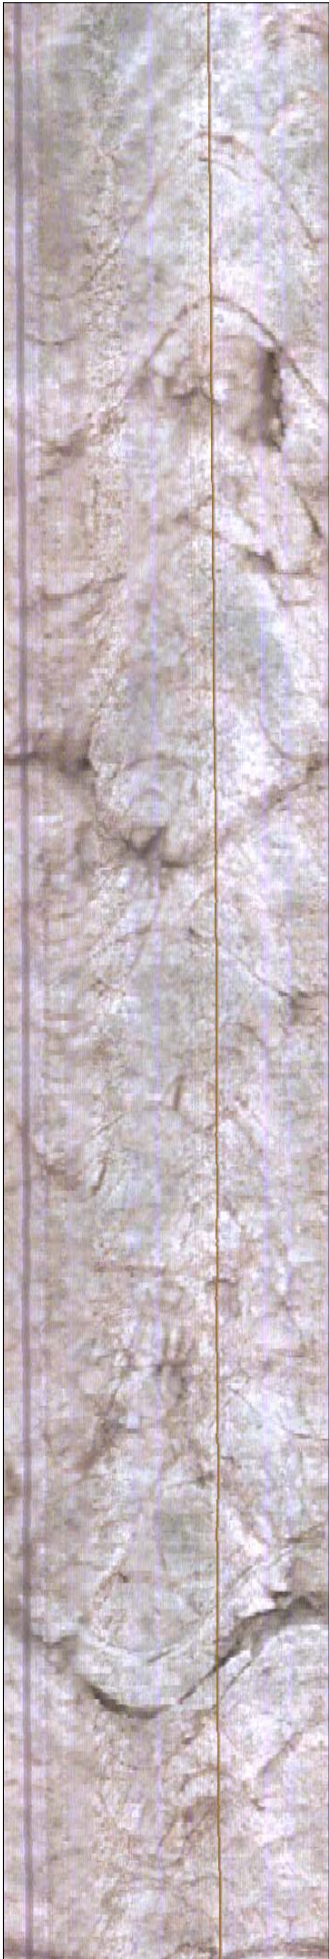
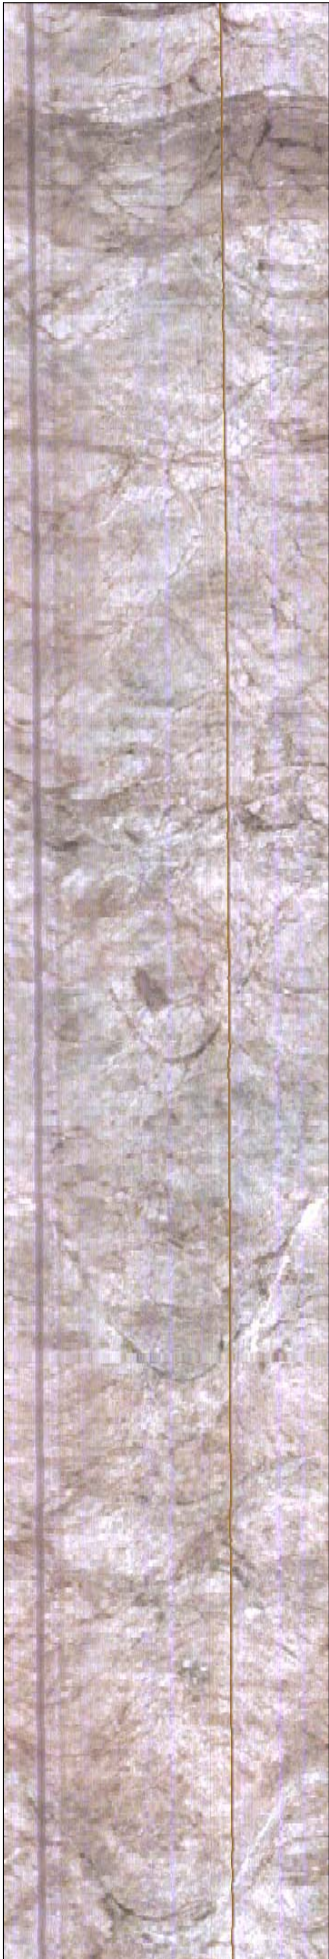
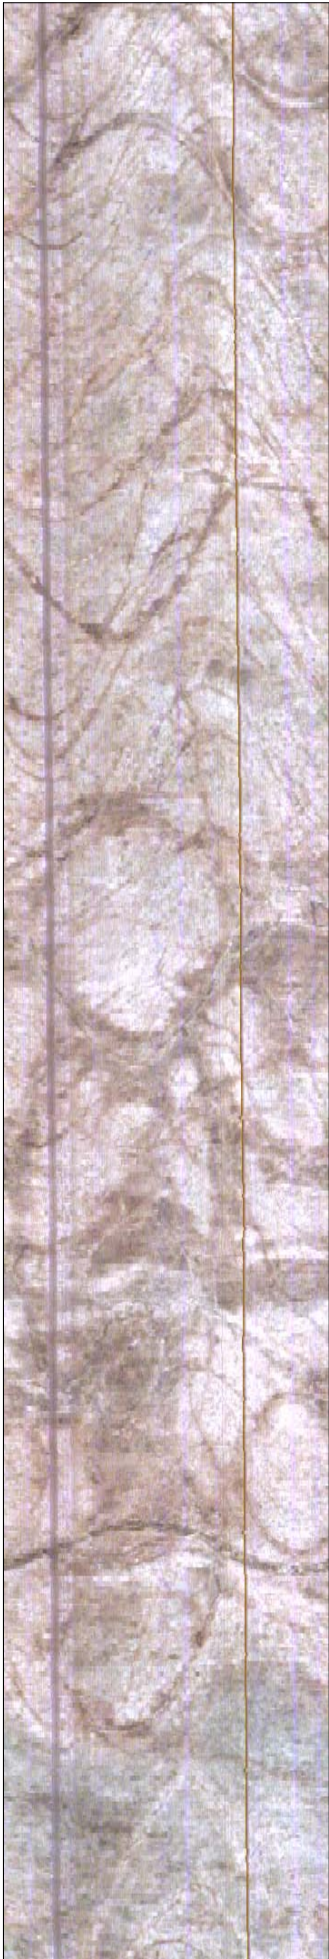
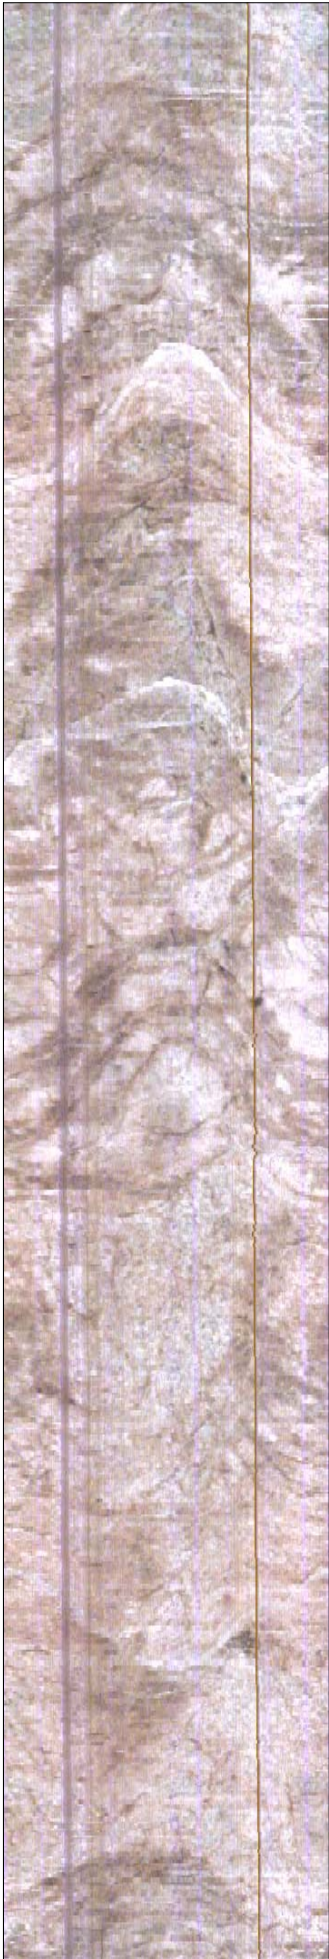
Orientation Summary Table
Televiewer Features
Shaw
Hermosa
Well: 37-B09
January 17-18, 2013

- Dip Directions analysis in borehole 37-B09 indicate approximately 26% of the identified features dip in the direction of 320 to 360 degrees (Northwest) and 25.5% dip in the direction of 140 to 200 degrees (Southeast). Dip Angles image indicate over approximately 66% of the features in 37-B09 are dipping at more than 50° from horizontal, while the remaining features are dipping at less than 50° from horizontal. There are 97 high-angle fractures or features (dip angles greater than 45°) that were identified in 37-B09. These 97 high-angle features represent 79.5% of all identified features from the optical televiewer and acoustic televiewer data set. The 97 high-angle features are qualitatively ranked 0 to 3, suggesting minimal flow potential from these features, with the exception of one high-angle feature ranked 4, suggesting a nominal flow potential.
